The **SAFEST WATER** In The World

Biofilm Removal

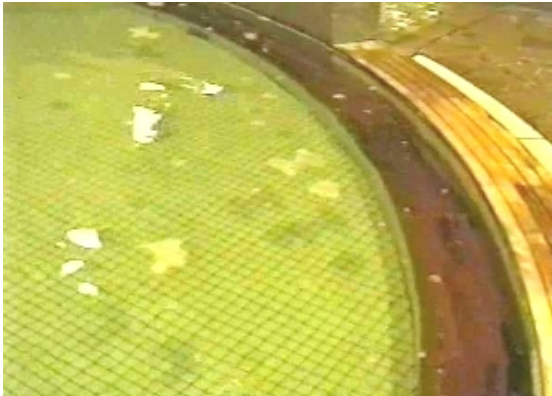
INONO HOT SPRINGS

Biofilm removal started within hours after MIOX system start-up

Upon conversion to mixed oxidants, sloughing was immediately apparent as particles of biofilm began to appear on the pool surface. Operators manually removed the biofilm and within one week of operation, the pool water was clear.

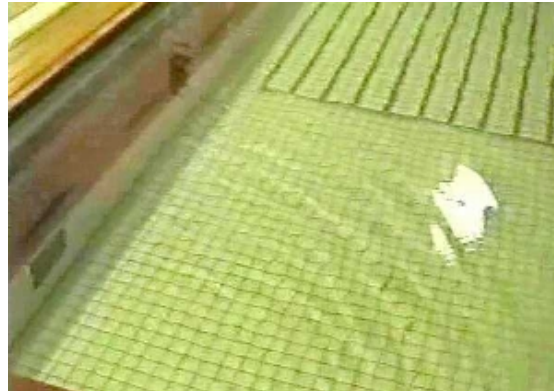
After 6 days, the pool was clean

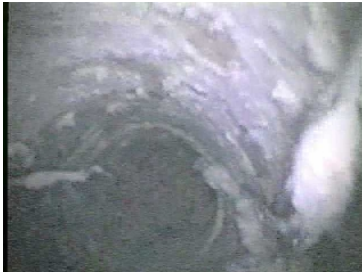
FEED WATER PIPE

Feed water pipe with sodium hypochlorite

Even more impressive was the videotape showing biofilm removal in the 4-inch pipelines. In the feed water pipe, substantial removal was evident after 6 days, and during the last videotaping at 22 days, removal of biofilms was total. The same phenomenon occurred in the filter recirculation pipe with the entire filamentous mass completely eliminated.

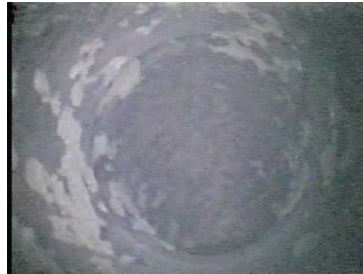
After 6 days with mixed oxidants

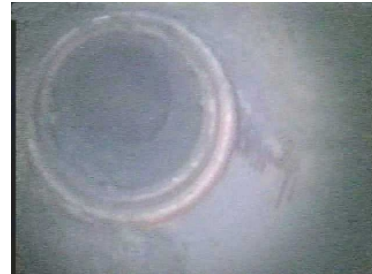
After 22 days with mixed oxidants

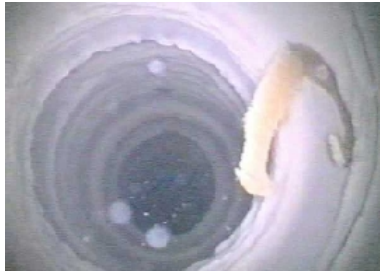
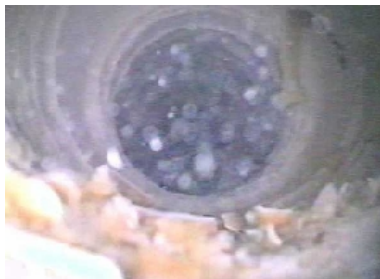
FILTER RECIRCULATION PIPE

With sodium hypochlorite

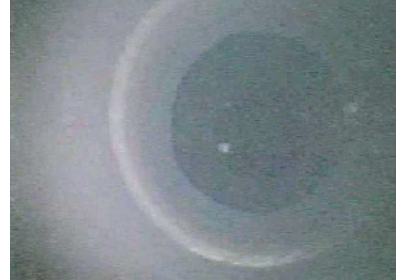
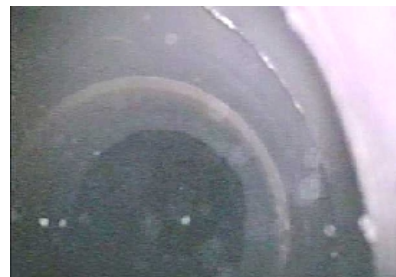
With mixed oxidants

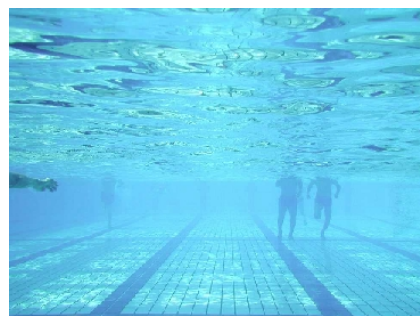
With mixed oxidants

Installations at Shibasaki Gymnasium in Tachikawa City and Miwa Town in the Aichi Prefecture of Japan, both initially using sodium hypochlorite disinfection, reported drastically improved clarity of the water after only 4-5 days of operation with MIOX mixed oxidants. Improved water clarity indicates a removal of biofilm contamination and/or algae growth responsible for the cloudiness in the water.

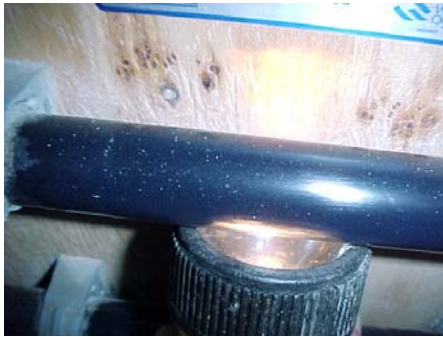
Black biofilm coating before application of mixed oxidants

In an unrelated study, Charles Smith of Quality Water Systems installed a small MIOX system on a bakery cooling tower for a pilot test.^{vi} Upon start of the test, the clear pipelines were completely obscured by a “leathery” black slime. Previous disinfection with hypochlorite had minimal impact on the biofilm contamination, and the pipes required cleaning within 10 days after disinfection was stopped. In contrast, mixed oxidants thoroughly broke down the biofilm. When the MIOX pilot system was removed, the bakery owners reported that it took 3 weeks for the biogrowth to reform, and even at that point, the “leathery” texture was not apparent, so cleaning was unnecessary. Mixed oxidants removed even the tough substrate that allows more rapid regrowth of biofilm.

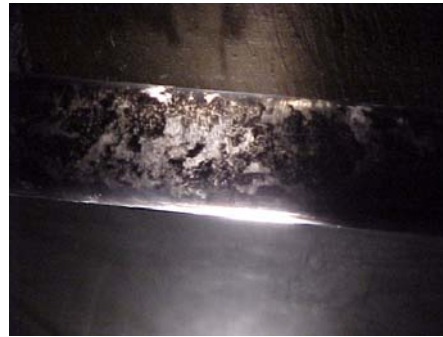
Breakdown of biofilm begins with mixed oxidants

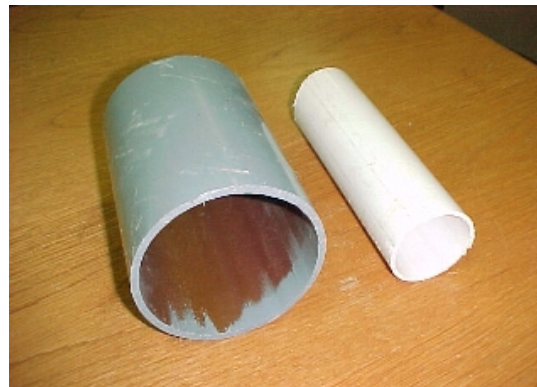
Biofilm contamination on chlorine-treated line (left) versus mixed-oxidant line (right) at Diana Water Supply

Diana Water Supply in Texas has a number of well sites and has been gradually converting from chlorine gas disinfection to MIOX mixed-oxidant generation, beginning in 1996. Several years ago, two line breaks occurred around the same time, one on a line treated with chlorine gas and the other on a line treated with mixed oxidants. Both pipelines had been in use for more than ten years, and both were originally on chlorine gas. The conversion to mixed oxidants on the second line had taken place about one year prior to the line break. The chlorine treated line was only 200 feet from the disinfection station, yet it was coated with a brown slimy substance. In contrast, the mixed-oxidant treated line was half a mile from the disinfection station, but the line was completely clean.

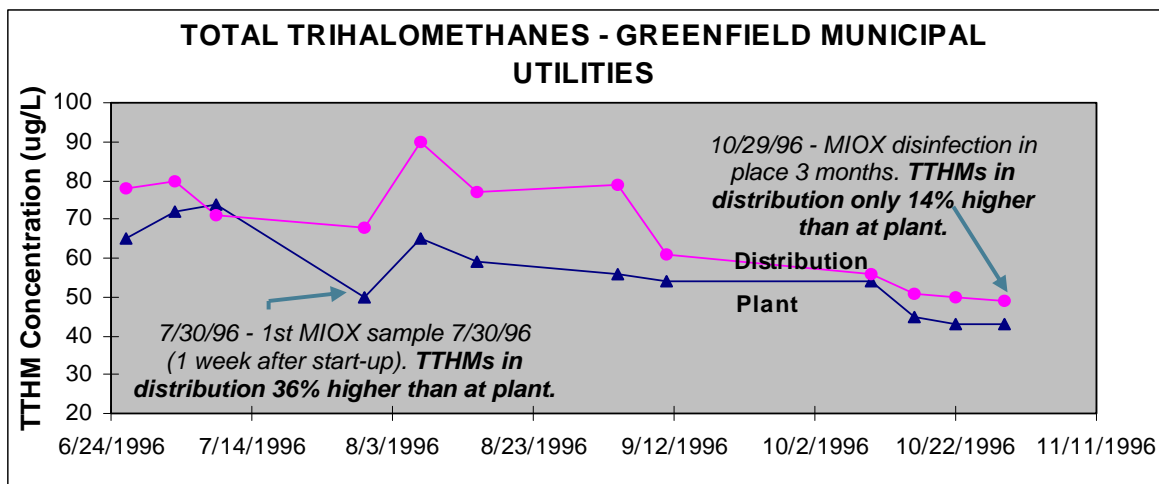
Greenfield Municipal Utilities in Iowa monitored total trihalomethanes (TTHMs), by-products of chlorine disinfection applied to water containing organic material.^{xii} TTHMs in the distribution system are typically higher than at the plant, due to organic material (biofilm) in the lines that continues to react with chlorine in the water stream. While Greenfield's TTHM levels both at the plant and in the distribution system were lowered with mixed-oxidant treatment, the results were more drastic in the distribution system. At the beginning of the monitoring period in late July, TTHMs were 36% higher in distribution than at the plant. At the end of the 3-month study, TTHMs were only 14% higher in distribution than at the plant, indicating removal of organic material from the pipelines.
